WA Country Health Service and Department of Finance
(Building Management and Works)

Removal Management Plan – Asbestos Containing Materials, Busselton Health Campus

June 2014

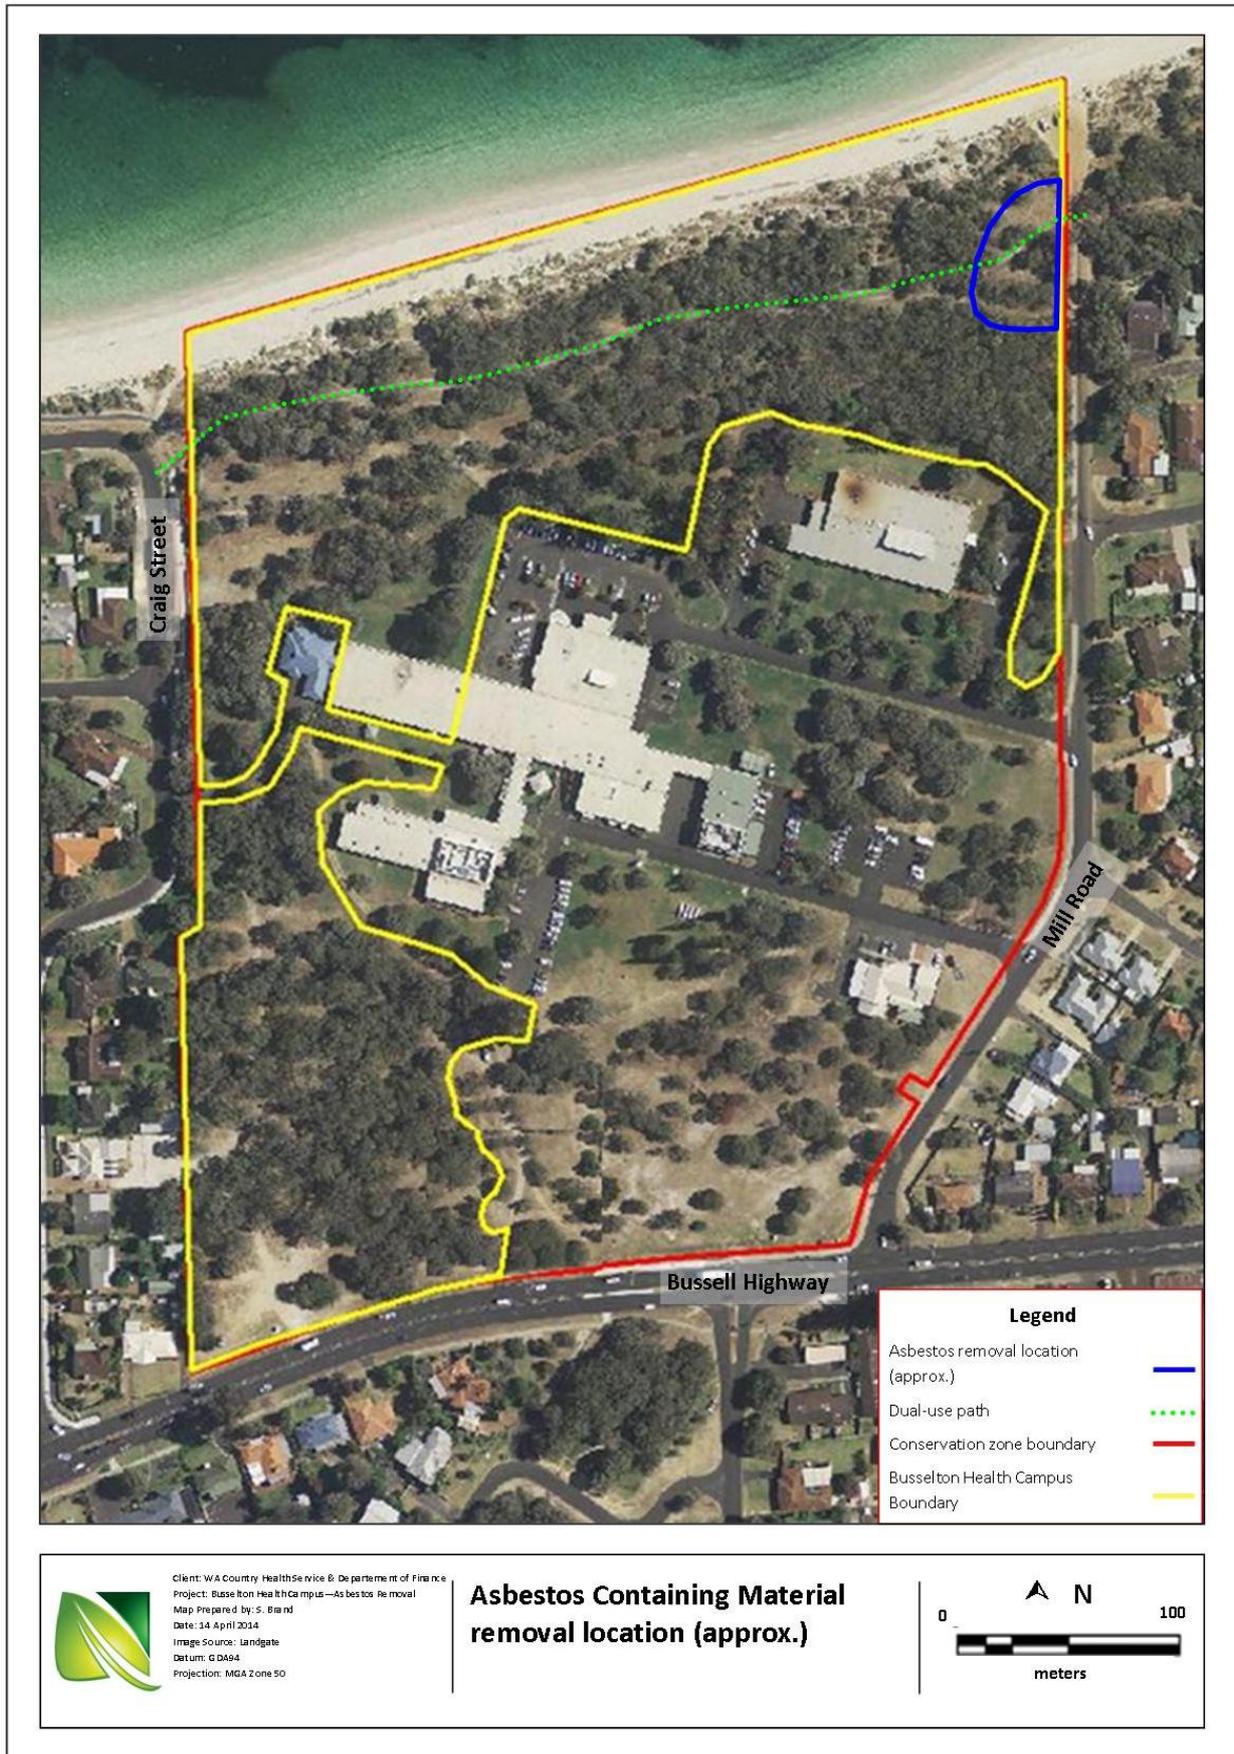
Figure 1: Asbestos Containing Material removal location

During site assessment activities associated with the preparation of the Conservation Zone Revegetation Management Plan for the Busselton Health Campus, an area with fibre cement was observed in the northeast portion of the site in the vicinity of the dual use path (Figure 1). Subsequent investigation of the material confirmed that it contained asbestos fibres at levels that indicate that site is considered to be contaminated under the *Contaminated Sites Act 2003* (WA), and that clean up is required. This management plan documents the clean up process and associated monitoring requirements, particularly those with the implementation of dust monitoring.

The Busselton Health Campus is located approximately 2.5 km west of the Busselton town centre at 189 Bussell Highway. It is bounded by Bussell Highway to the south, Craig Street to the west, Geographe Bay and the Indian Ocean to the north, and Mill Road to the east (Figure 1).

The asbestos containing material (ACM) is confined to the north-eastern portion of the site in the vicinity of the dual use path (Figure 1). The majority of the ACM is fragments lying on the surface to an estimated maximum depth of 30 cm (300 mm). Testing carried out by Aurora Environmental in February 2014 indicated that fine materials were also present in some locations.

Testing undertaken by Aurora Environmental in February 2014 indicated that the majority of the asbestos at the Busselton Health Campus is in the form of larger pieces of asbestos containing material and is concentrated within the top 30 cm (300 mm) of the land surface. However, two of the test pits also revealed the presence of asbestos fines associated with weathering over time at concentrations greater than Department of Health guideline values of 0.02% w/w for parks and public open space areas. The asbestos materials are confined to an area of approximately 1100 m² in the north-east portion of the site around the dual-use path (Figure 1). The amount of material present means the risk of exposure is low – medium, and will be cleaned up.

Site assessment activities have suggested that the contamination is confined to the area shown in Figure 1. However, the possibility will remain that fragments of asbestos may be found in the future. These will be manually collected and bagged prior to disposal at landfill on an as required basis. Removal and disposal will be in accordance with Department of Health asbestos guidelines (2009).
